STRATUM GROUP

May 6, 2010

Re: **Geology Hazard Assessment
For Vegetation Management**
Timberton Village Home Owners Association
Port Ludlow, Washington

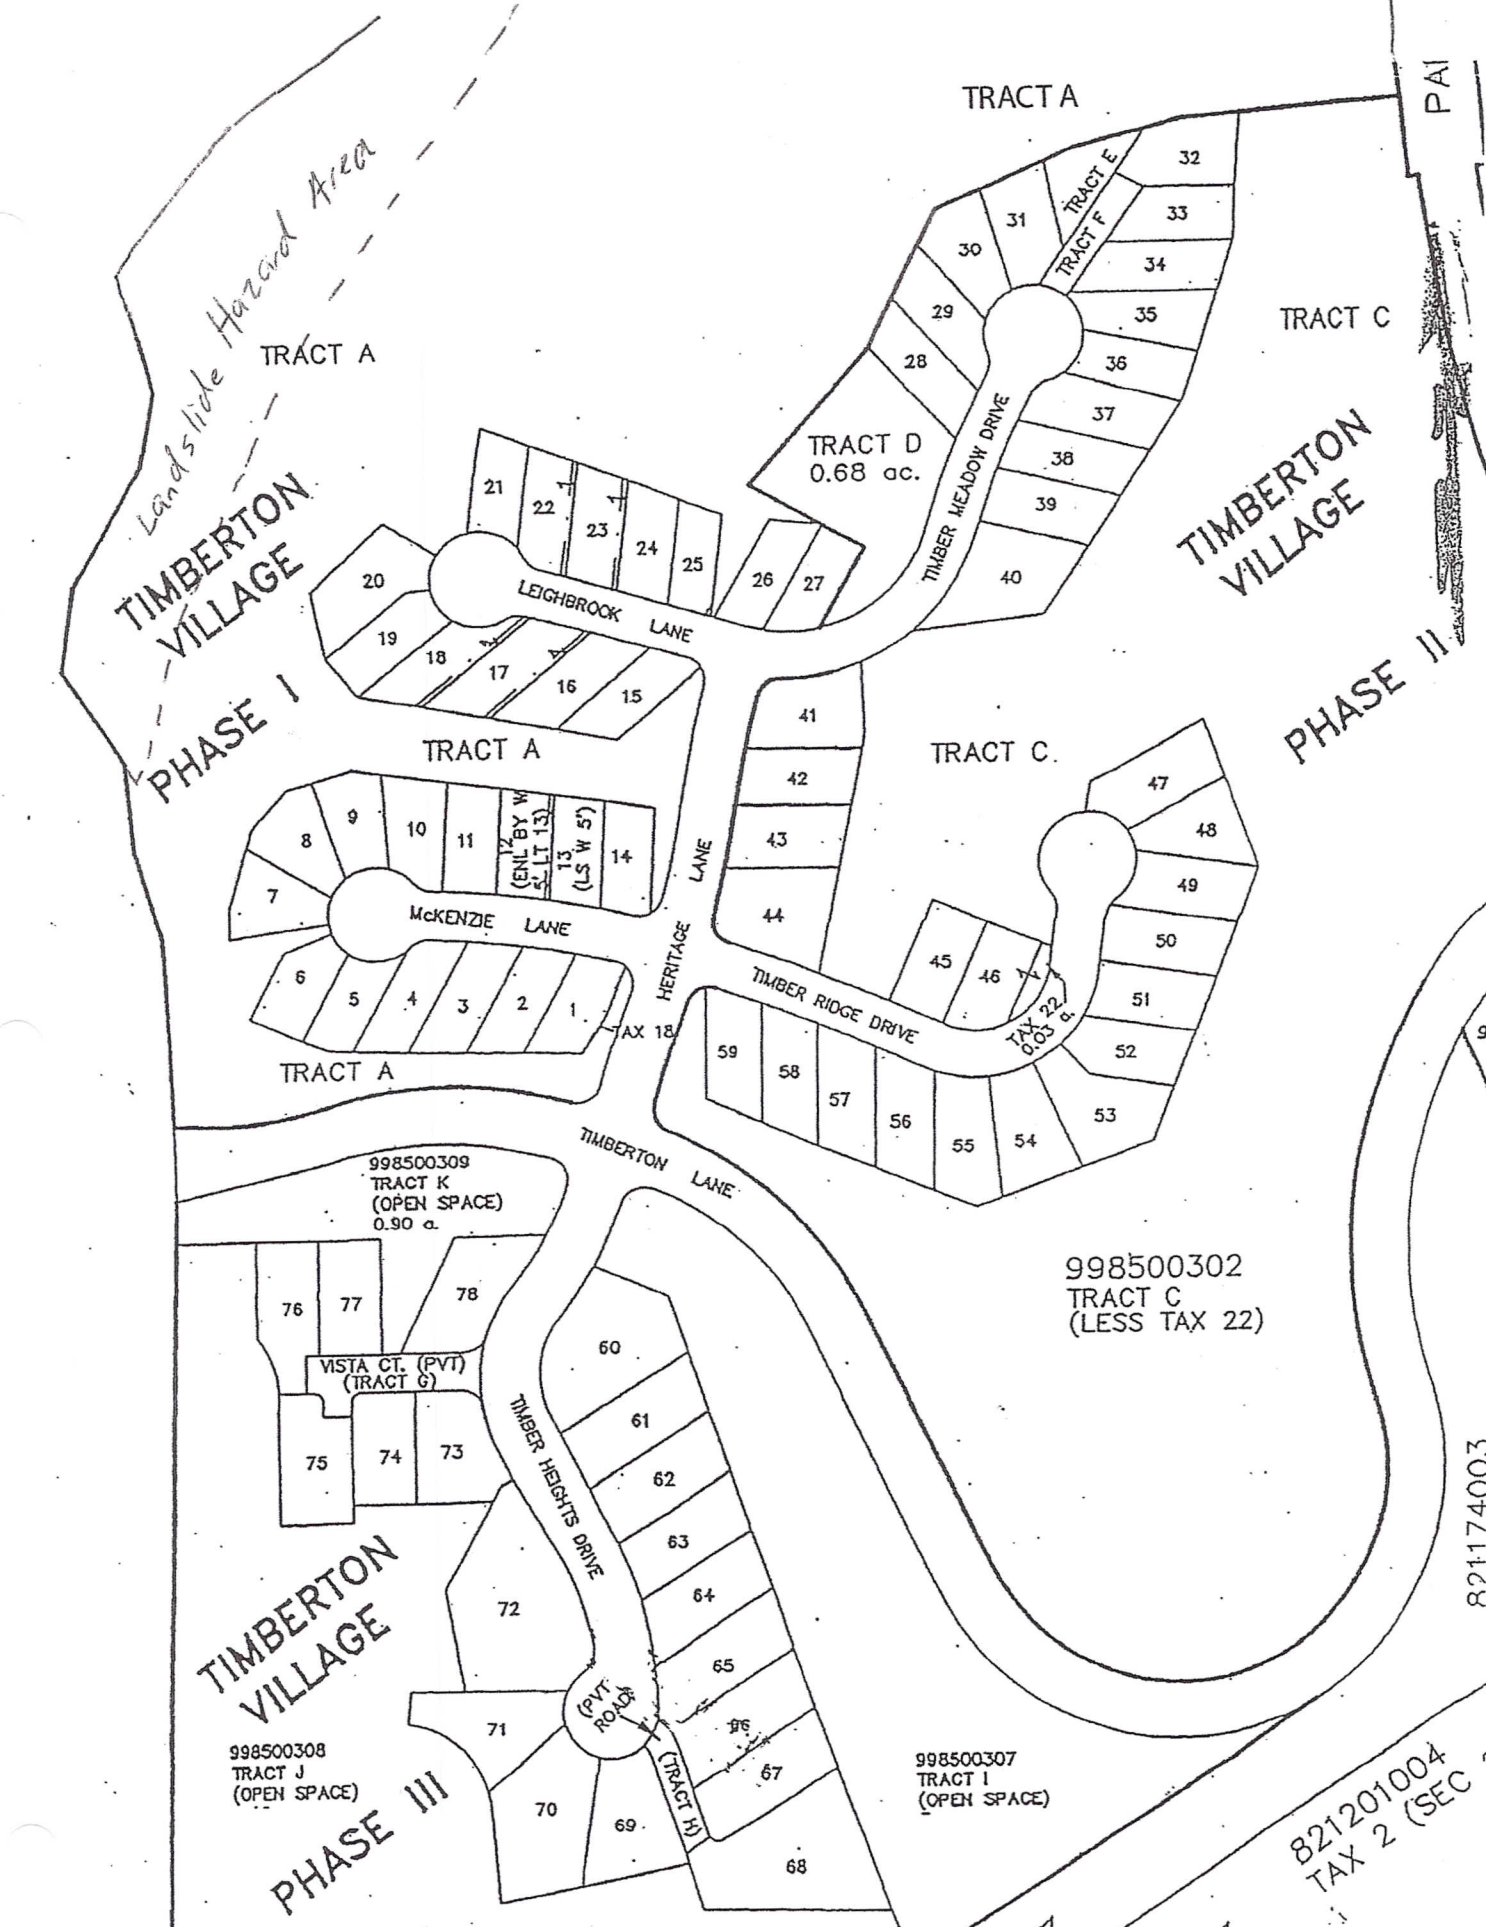
Based on my observations there are no landslide hazards on any of the tracts with the exception of the steep slope immediately above the stream area on the west side of Tract A. This location labeled as a Landslide Hazard Area on Figure 2 and 5 and as a Special Management Area on Figure 4. Minor shallow soil failures should be expected in this area. On the steep slope on the west side of Tract A within the Special Management Area at least one mature tree per 30-foot center should be left in place and understory vegetation should not be disturbed in this area. Because of the proximity to the stream other considerations may be required regarding vegetation management in this area.

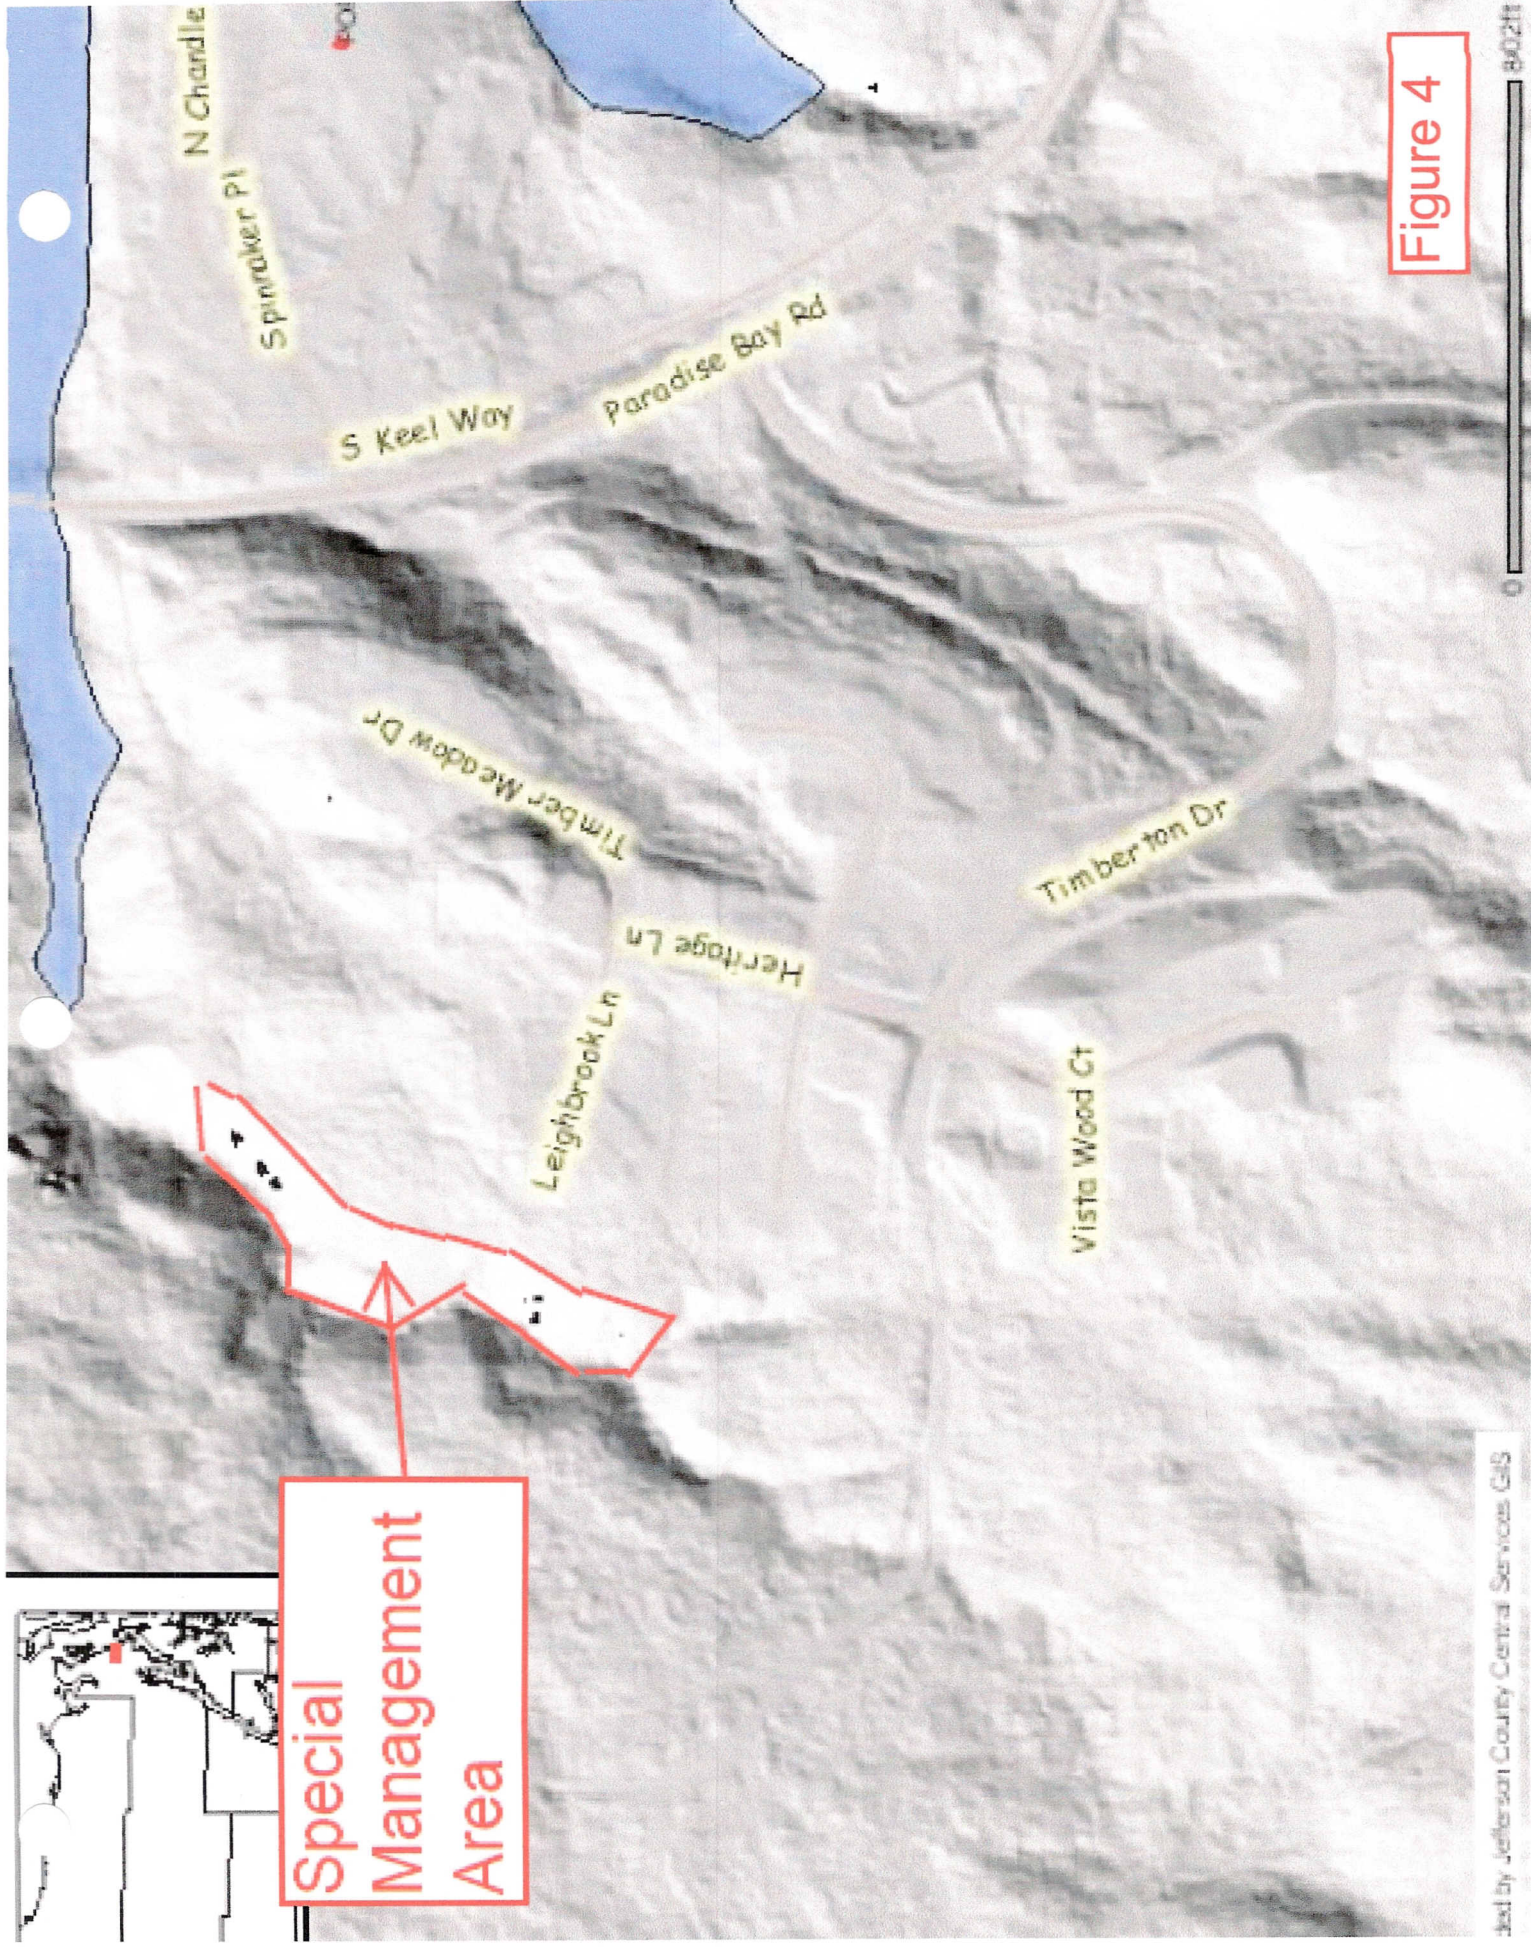
Figure 4

Based on my observations of existing slope conditions, past tree removal on portions of the slopes, and soil conditions, it is my opinion that tree removal will not have adversely impact the stability of the slopes on any of the tracts with the exception of the steep slope on the west side of Tract A immediately above the riparian area as indicated on Figures 4 and 5.

**Special
Management
Area**

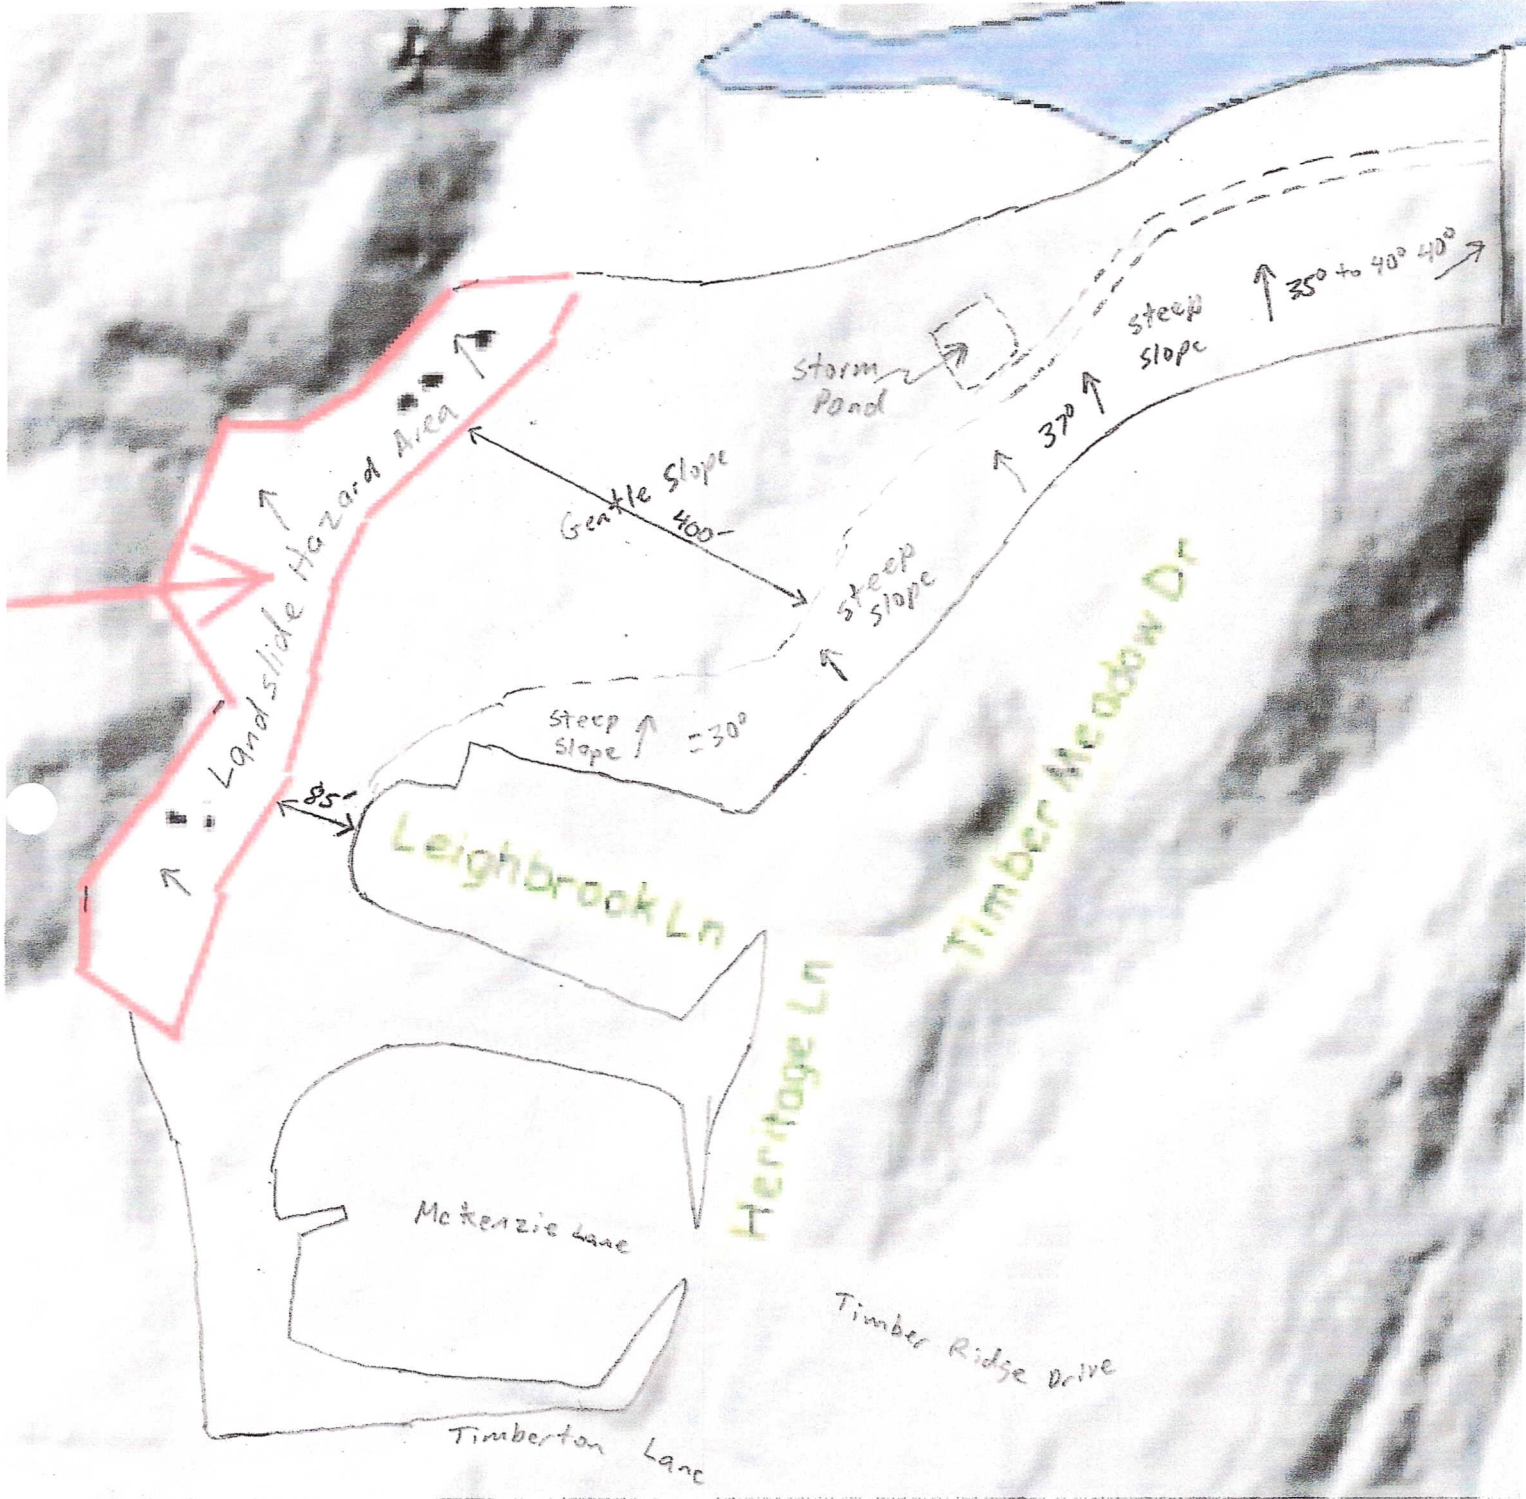
Figure 5 sketch map of Tract A

Tract A is located on the west side of the development. A sketch map of Tract A is provided in

Figure 5 with the pertinent features indicated.

The only other steep slope on Tract A is located on the slope immediately above the stream that bounds the west side of Tract A. This slope as steep as 45 degrees and in places are over steep from stream incision. Minor shallow soil failures should be expected on these slopes and the slope is potentially unstable to unstable.

Based on the site inspection, review of available information and my professional judgment, it is my opinion that slopes on the subject property are stable with the exception of the steep slope on the far west side of Tract A adjacent to an unnamed stream. On the steep slope on the west side of Tract A as indicated on the site map at least one mature tree per 30-foot center should be left in place and understory vegetation should not be disturbed in this area.

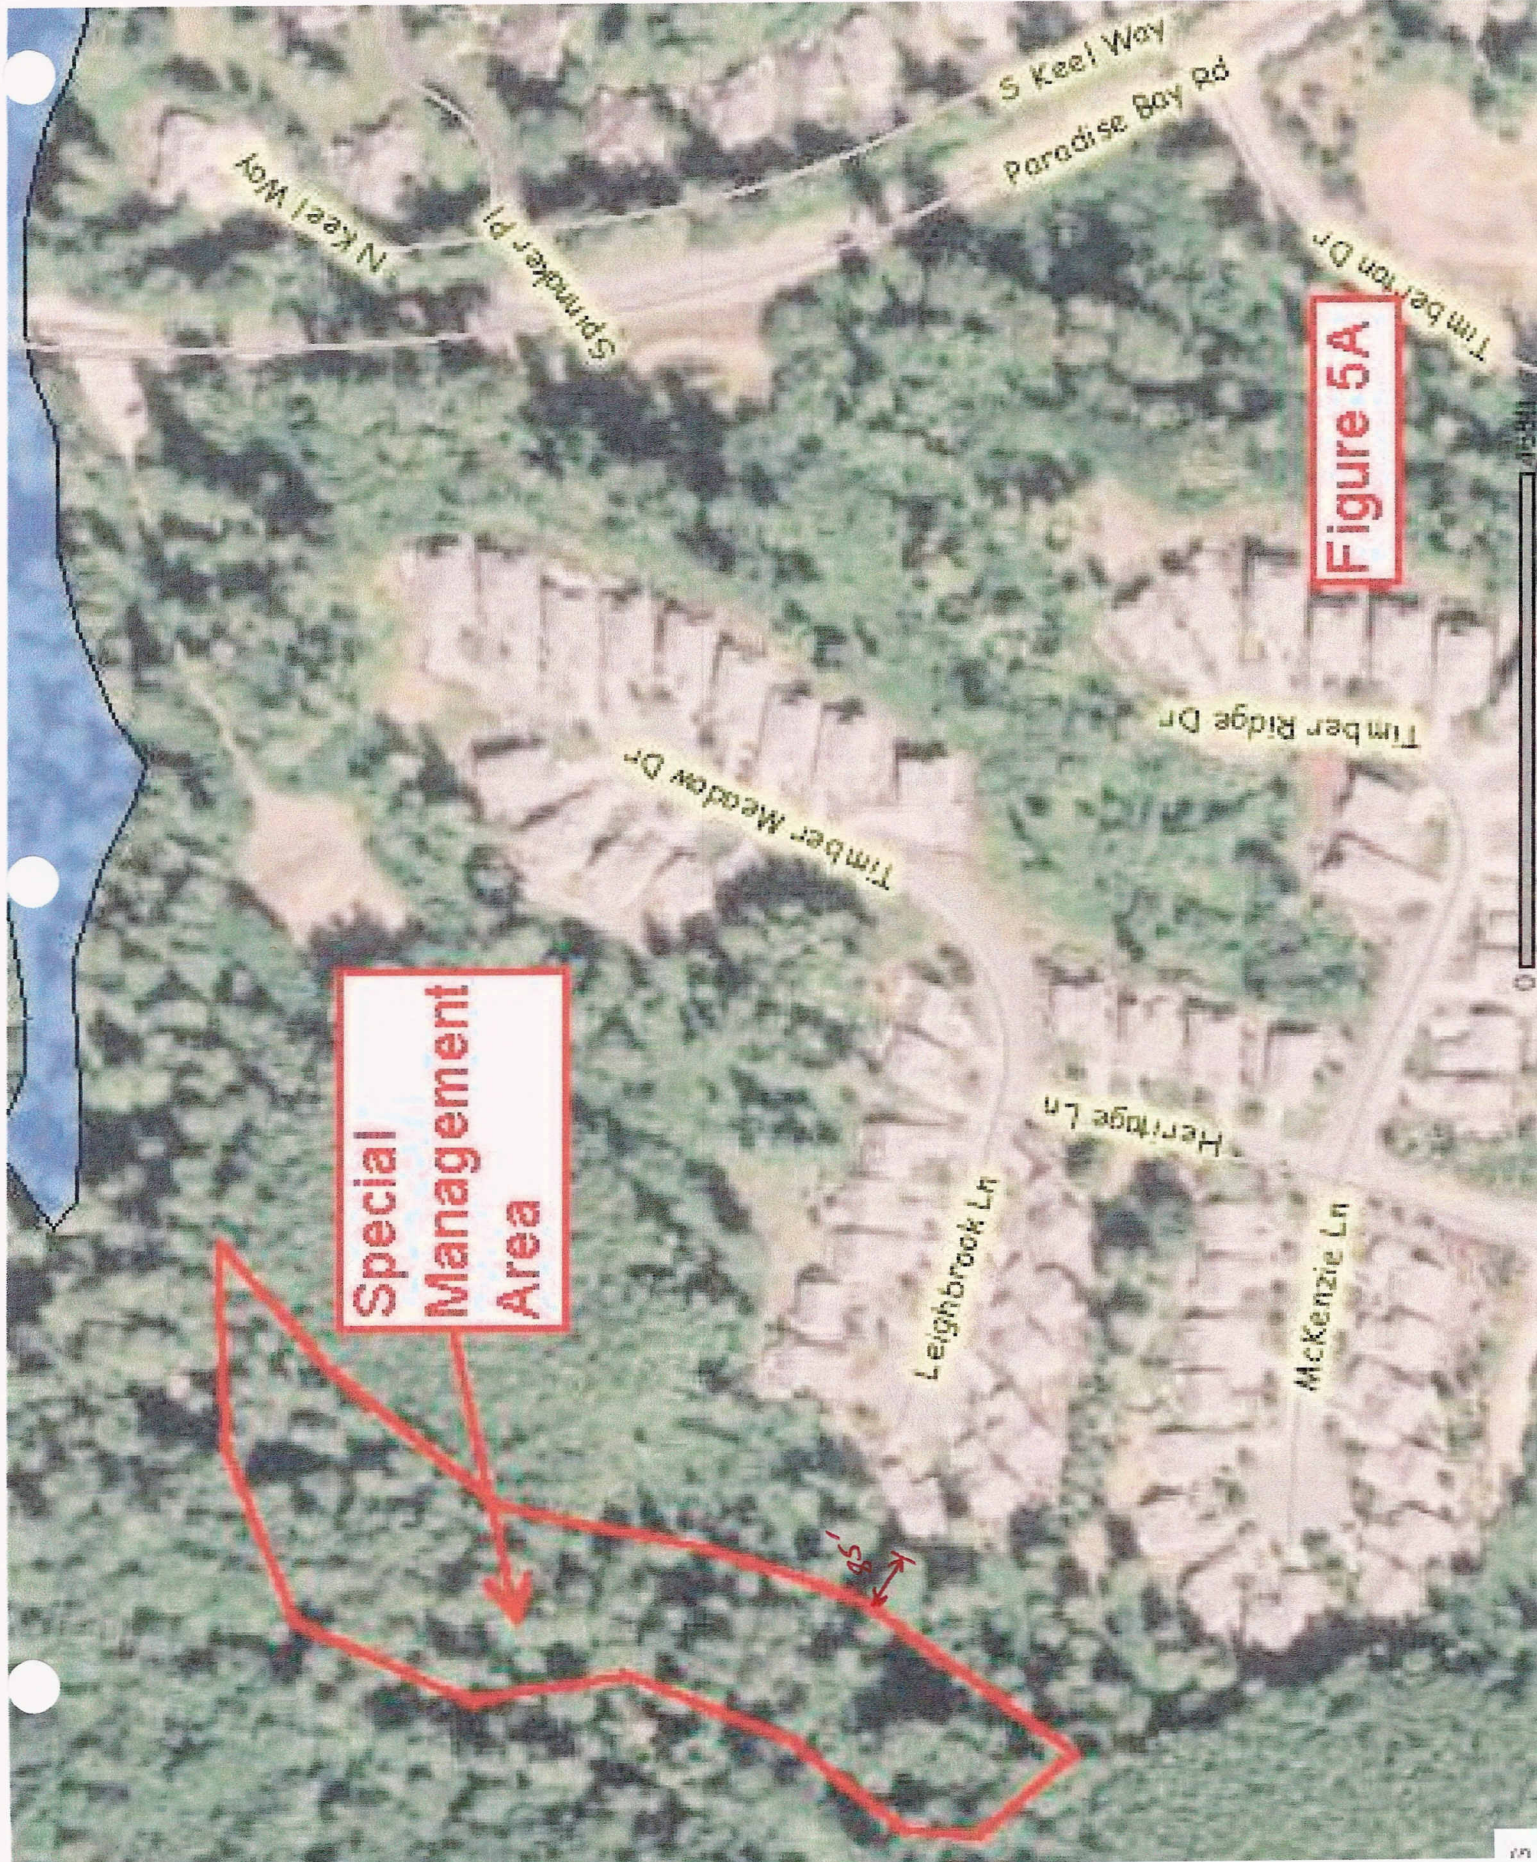
Figure 5A

Special Management Area
