STRATUM GROUP

May 6, 2010

Re: **Geology Hazard Assessment
For Vegetation Management**
Timberton Village Home Owners Association
Port Ludlow, Washington

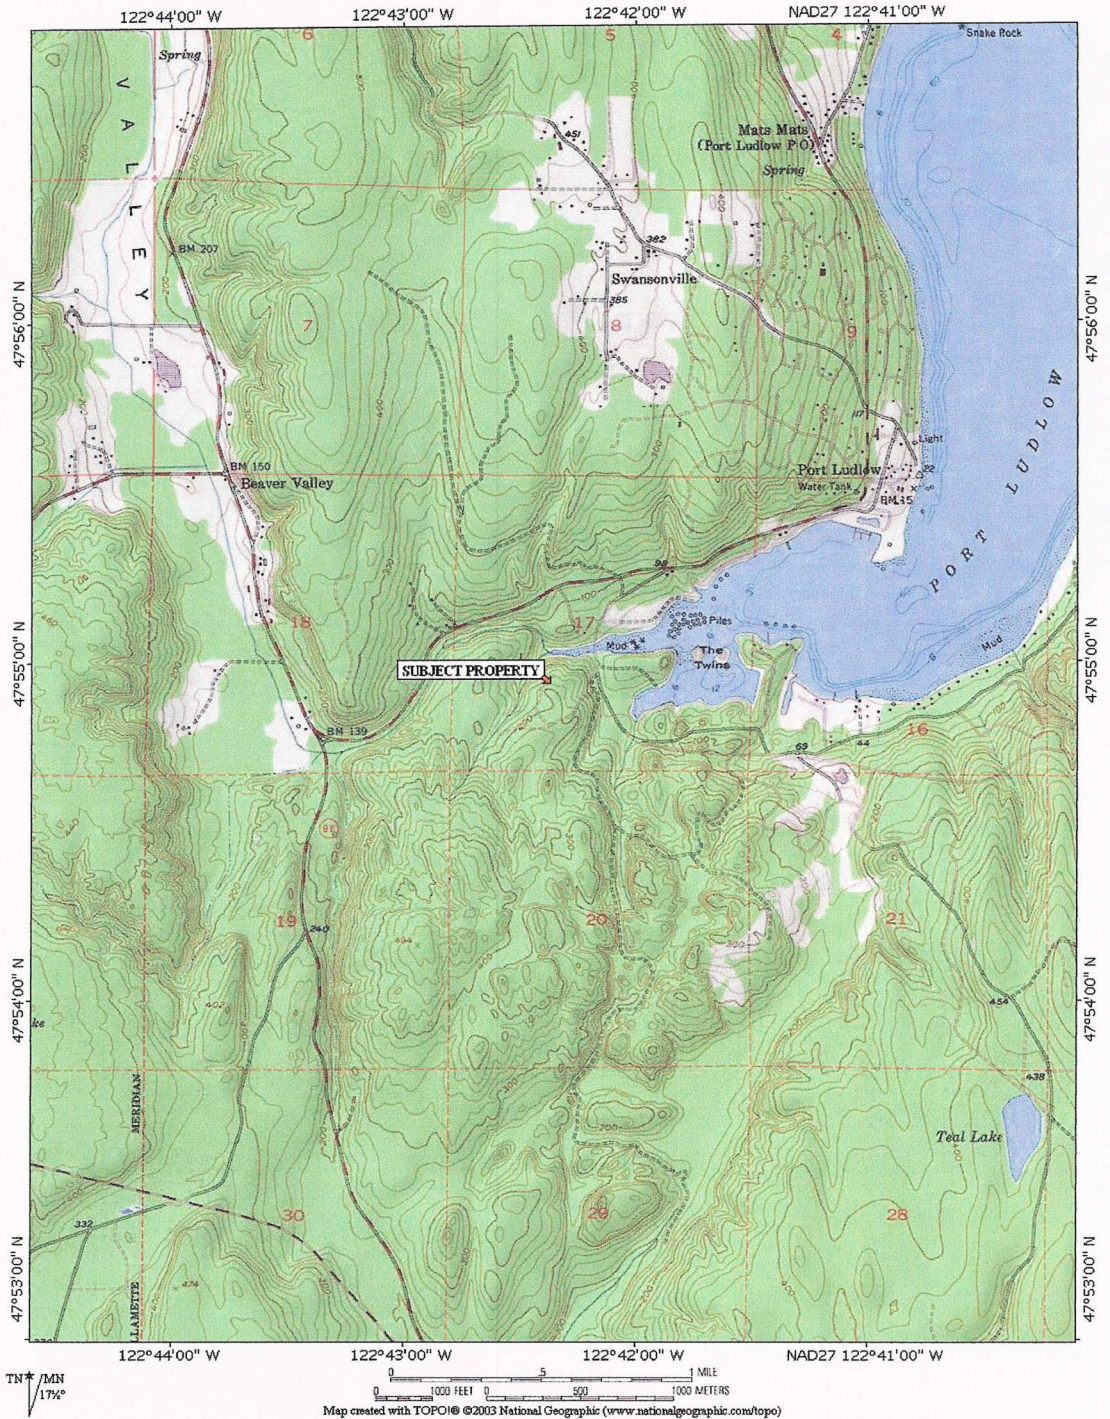
Based on my observations there are no landslide hazards on any of the tracts with the exception of the steep slope immediately above the stream area on the west side of Tract A. This location labeled as a Landslide Hazard Area on Figure 2 and 5 and as a Special Management Area on Figure 4. Minor shallow soil failures should be expected in this area. On the steep slope on the west side of Tract A within the Special Management Area at least one mature tree per 30-foot center should be left in place and understory vegetation should not be disturbed in this area. Because of the proximity to the stream other considerations may be required regarding vegetation management in this area.
